EXAMPLE INSPECTION REPORT

1234 N. Example St
WICHITA , KS ,USA

Prepared for: Example Client

Prepared by: Tom F. Beard Building Inspections, L.C.
934 N. Shefford
Wichita KS 67212

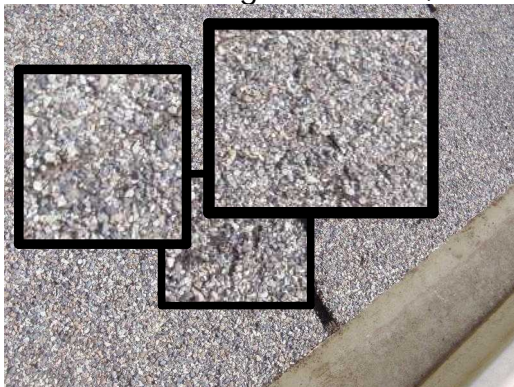
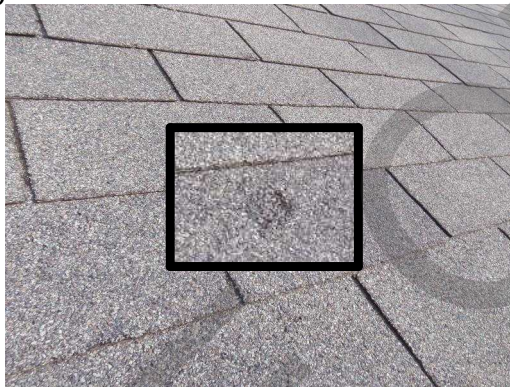
1. House Roof Surface Material: Composition Shingle - , found some light de granulation damage indicative of hail impacts, See example pictures, recommend further evaluation of damage by licensed Roofing contractor, and your Insurance carrier for insurability,

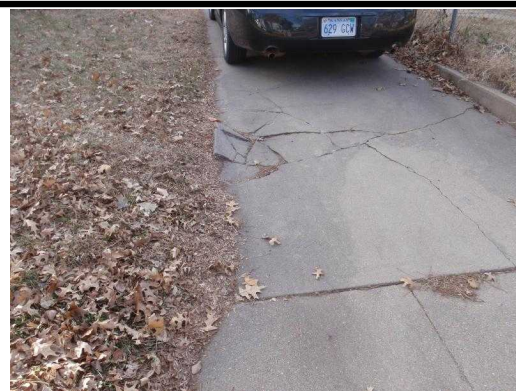
2. Driveway: concrete - , recommend replacement to raised and broken east slab,

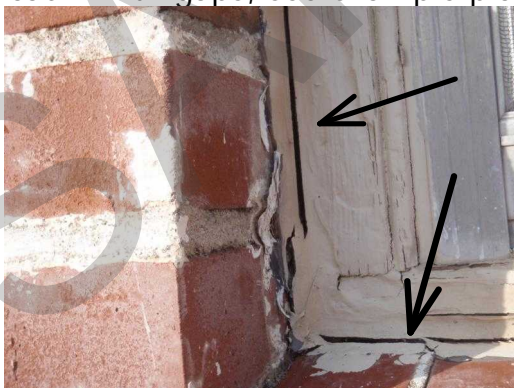
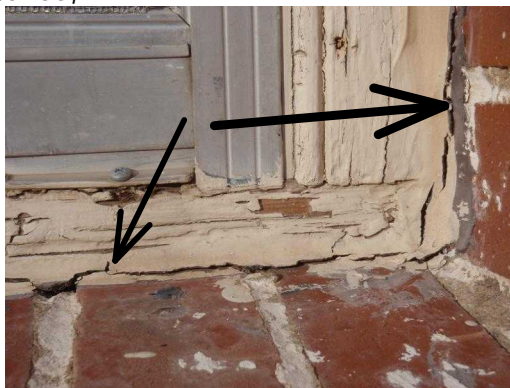
3. Flashing: Metal/ caulking. , recommend re caulking window frame wall joints that have cracked caulk with gaps, see example pictures,

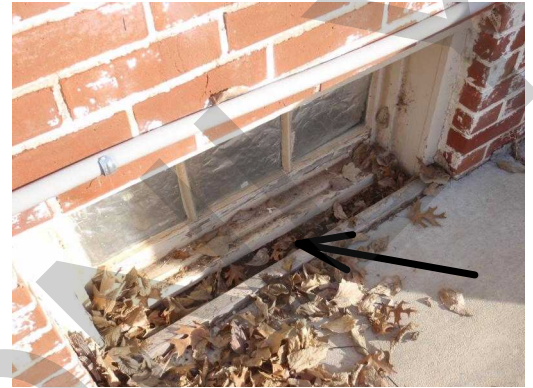
4. Basement Windows: west basement window at patio, - sill below grade, debris and water trap, recommend plastic cover over window to help divert debris and water away from sill,

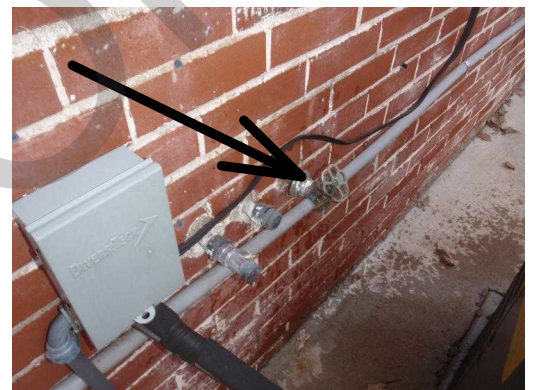
5. Hose Bibs: Gate - on west wall appears to be well feed, recommend upgrade to frost free bib or winterizing during winter months,

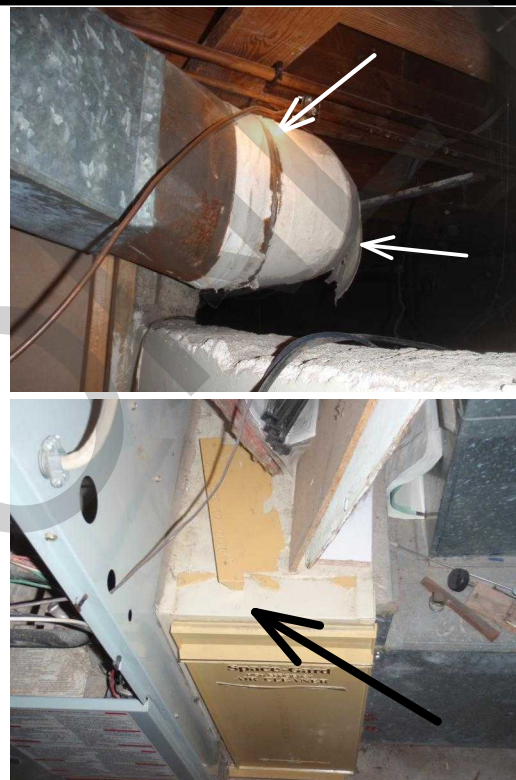
11. Basement, Utility room Heating System Exposed Ductwork: Metal - . loose friable asbestos wrap on duct in crawl, recommend encapsulation or removal by qualified contractor,
12. Basement, Utility room Heating System Blower Fan/Filter: Direct drive with reusable filter - Filter on slide tray at Furnace, recommend clean out at move in and every 2- 3 months. Filter cover broken, recommend new repair to secure cover,

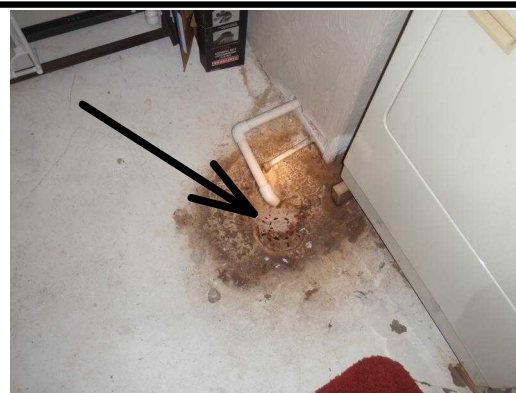
13. Floor drain: Surface Drain - , heavy build on floor at drain back up indicator, recommend asking seller if line cleaned since back up, recommend having underground lines scoped by plumbing contractor, due to past back up and slow drain at bath sink,

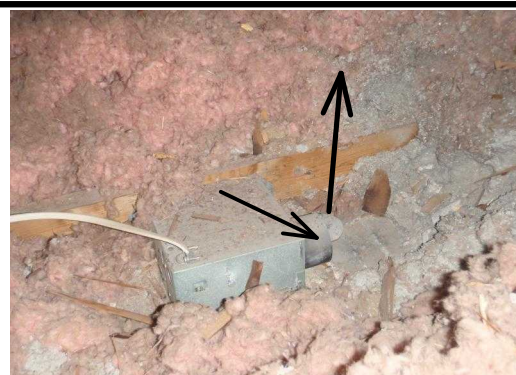
14. Main Attic Bathroom Fan Venting: Recommend vent hose on bath fan to roof structure, to allow insulation cover on fan at ceiling,

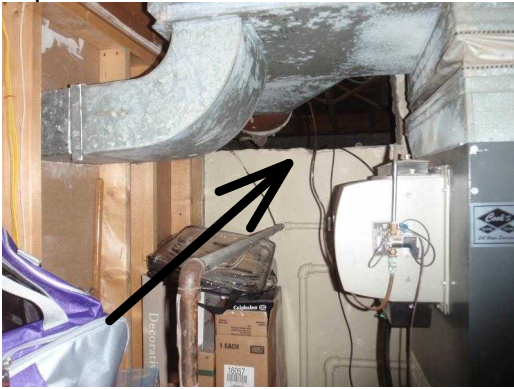
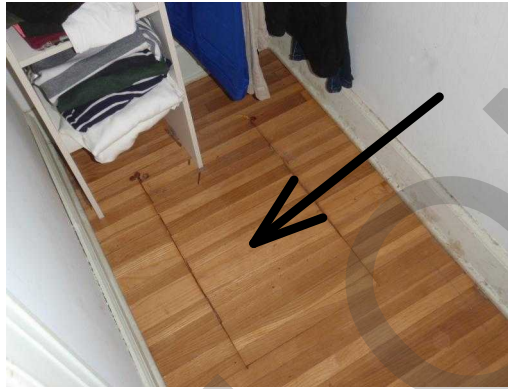
15. South Crawl area, Crawl Space Access: access from basement blocked by duct work and piping, p, - hatch in SW first floor bedroom closet floor in bind would not open, recommend repair to make inspection hatch in closet functional ,

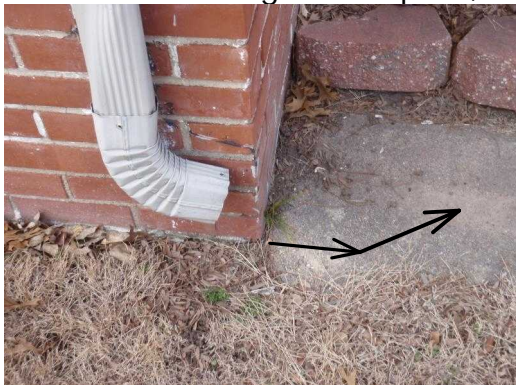
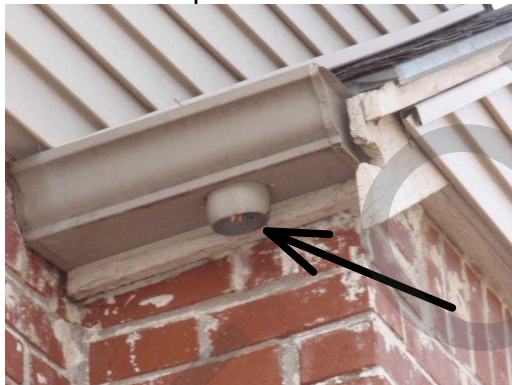
1. Downspouts: Aluminum - Recommend repair for SE down spout to drain to splash block, small front roof missing down spout, recommend replacement.

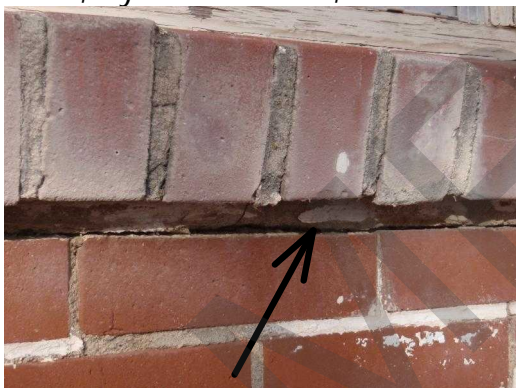
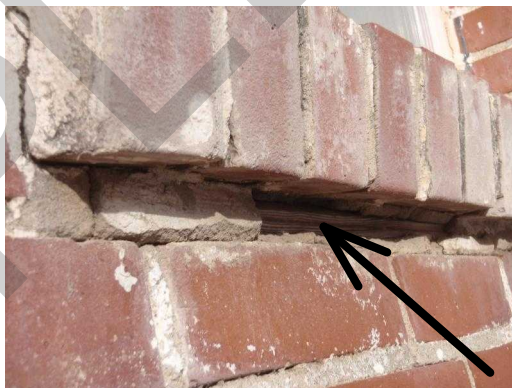
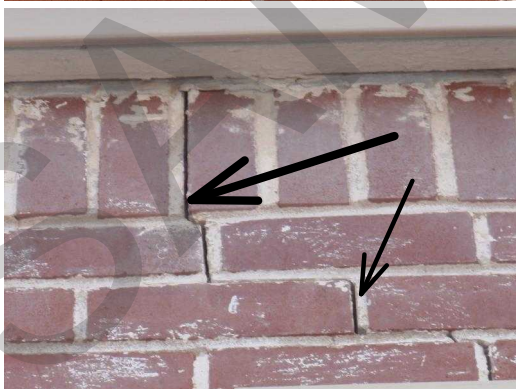
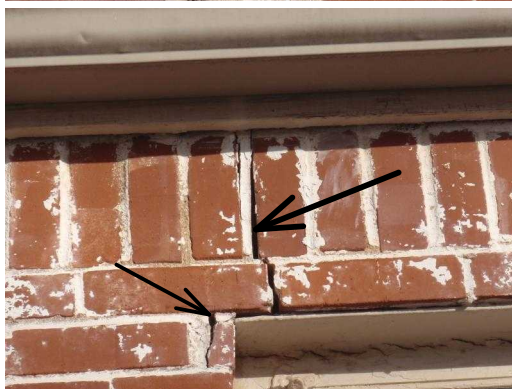
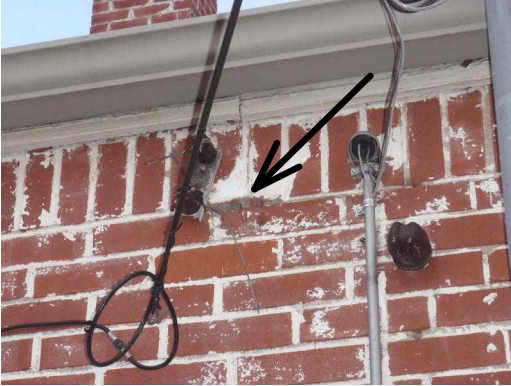
2. House Exterior Surface Type: Brick, Lap Siding - Recommend tuck point repairs to seal open cracks on upper east and west walls over windows, south wall at brick ledge brick, west wall over rear door, by brick mason,

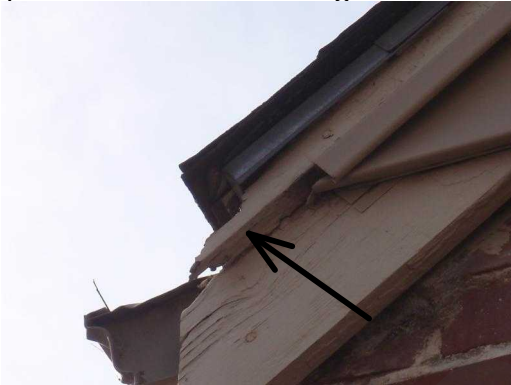
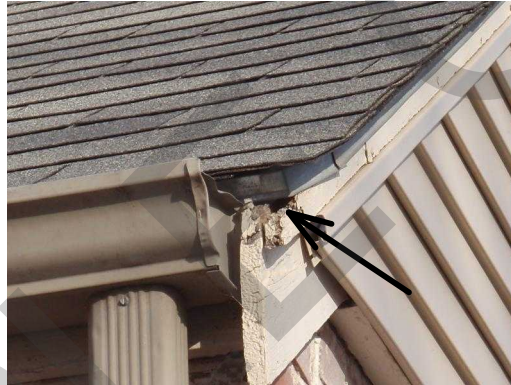
3. Fascia: Wood - Recommend repair to seal and paint open SE and SW fascia end corner boards, to prevent further damage,

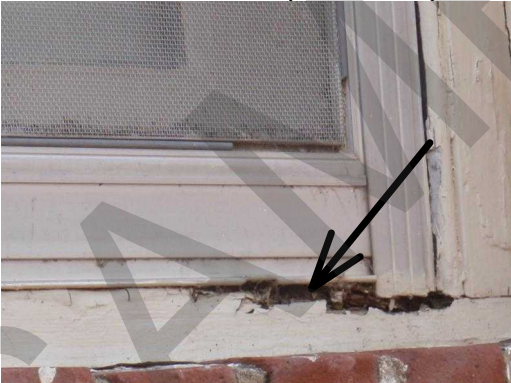
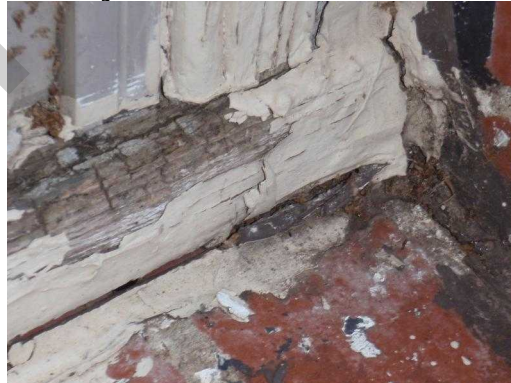
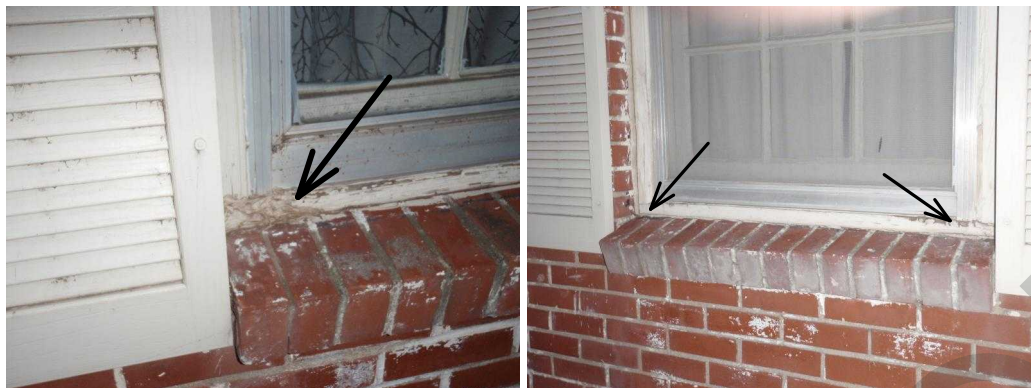
4. Windows: See flashing notes, - most windows due for paint and some glazing repairs, DEFECTIVE, Open dry rot on north wall and east wall window sills, recommend further evaluation and estimate to repair or replacement by window contractor,,

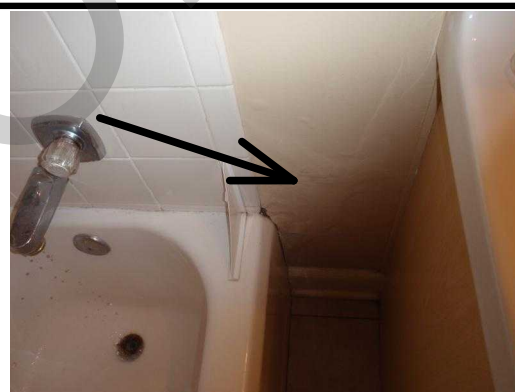
5. 1st floor main Bathroom Walls: crumbling water damaged area on west wall at tub, - recommend replacement to damaged area,

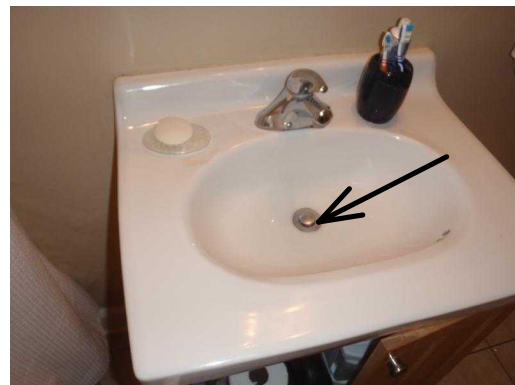
6. 1st floor main Bathroom Faucets/Traps: No visible leaks, , slow drain on sink, suspect trap due for cleaning, Recommend repair as needed to drain.

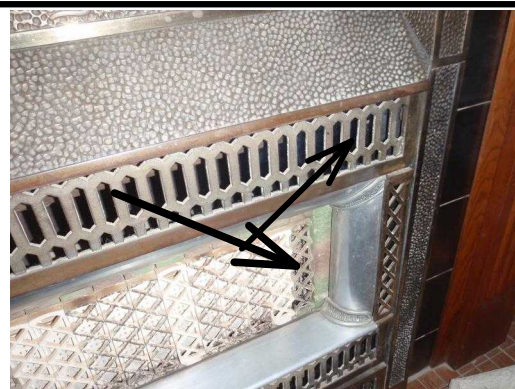
7. 1st floor main room Fireplace Gas/Starter: Lit and tested for function, , smoking at damaged ceramic element on right side of unit, elevated C O at start up, recommend full clean and inspection and repair as needed with flue inspection before use, by qualified contractor.

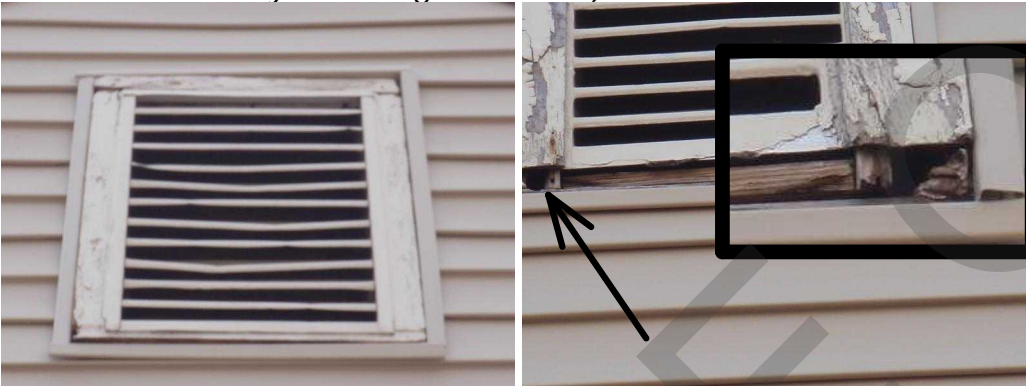
9. Main Attic Ventilation: Gable Vents - , Wood vents due for paint and caulk, open damage on north wall gable vent, recommend repair or replacement, (FYI< recommend additional roof vents to vent attic to today's venting standards),

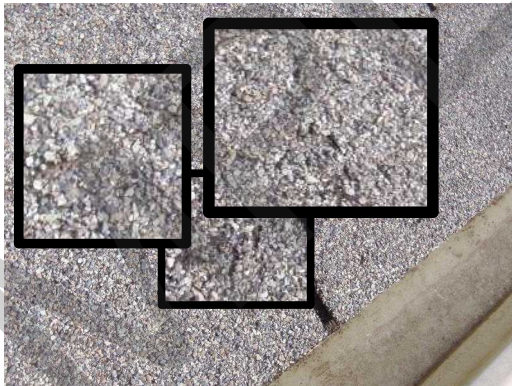
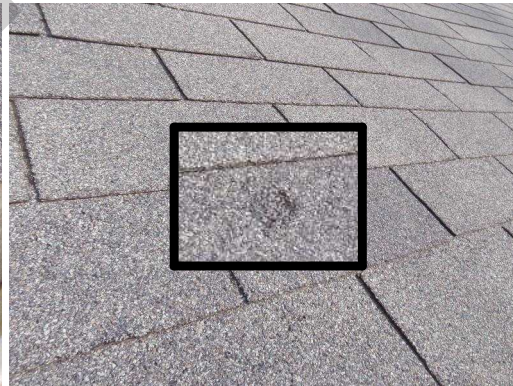
1. Method of Inspection: Due to steep slope on roof, unable to safely walk on roof, Inspection from ground. random check with ladder at gutter,
2. Marginal Material: Composition Shingle - , found some light de granulation damage indicative of hail impacts, See example pictures, recommend further evaluation of damage by licensed Roofing contractor, and your Insurance carrier for insurability,

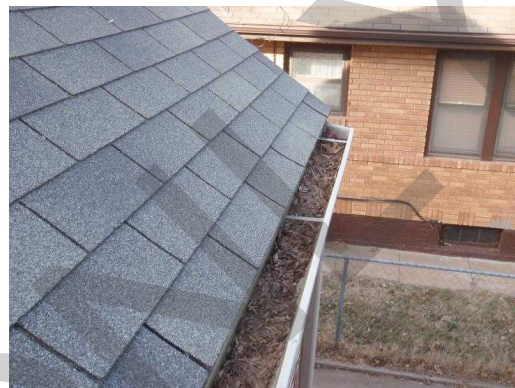
8. Acceptable Gutters: Aluminum, Due for clean out,

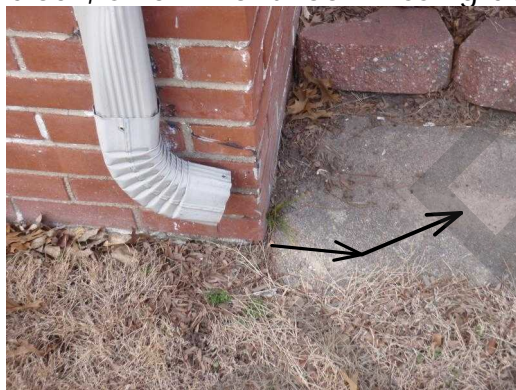
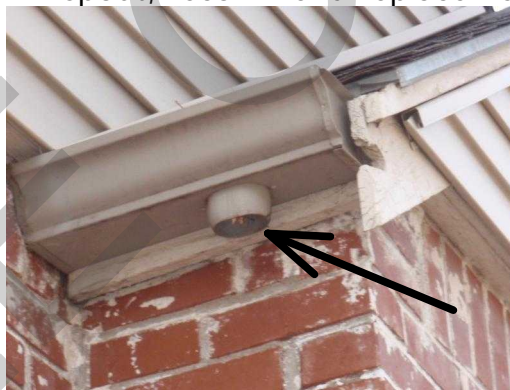
9. Defective Downspouts: Aluminum - Recommend repair for SE down spout to drain to splash block, small front roof missing down spout, recommend replacement.

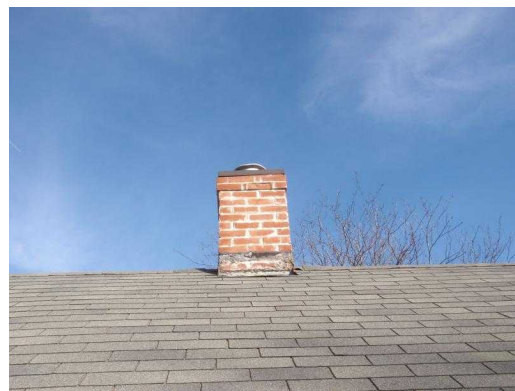
10. Acceptable Chimney: Brick, Masonry - No functional defects visible from ladder

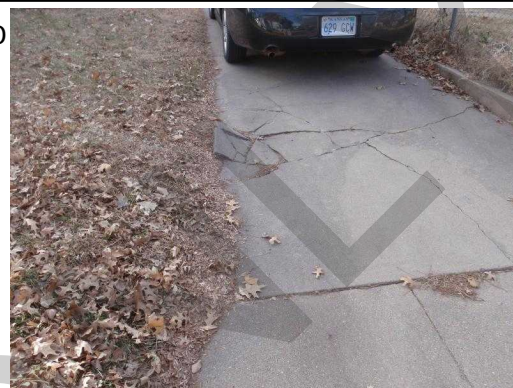
1. Marginal Driveway: concrete - , recommend replacement to raised and broken east slab,

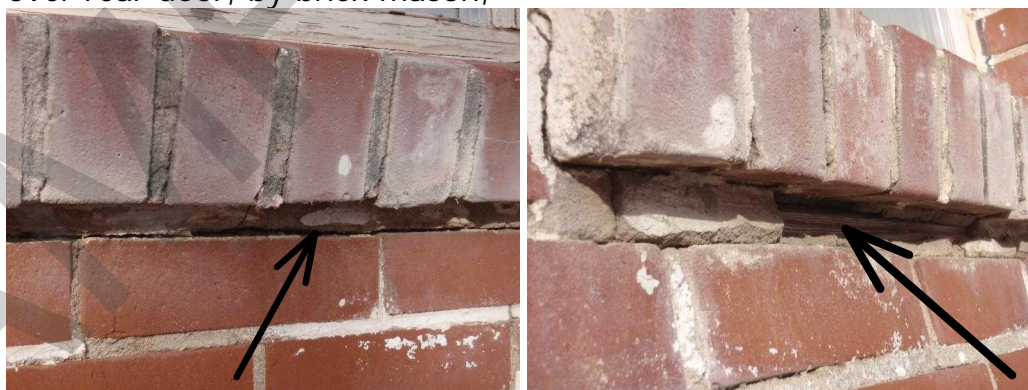
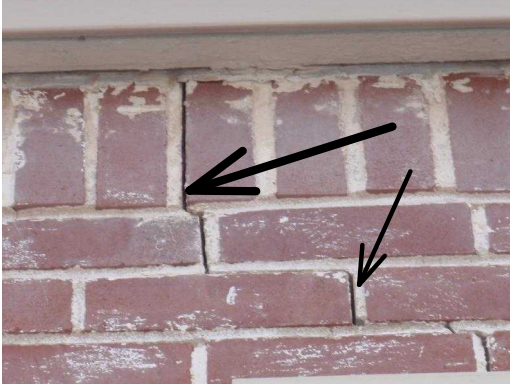
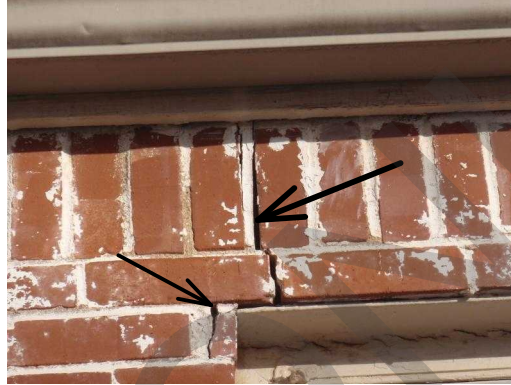
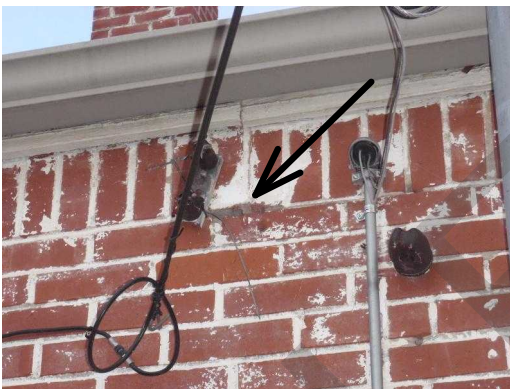
1. Defective Type: Brick, Lap Siding - Recommend tuck point repairs to seal open cracks on upper east and west walls over windows, south wall at brick ledge brick, west wall over rear door, by brick mason,

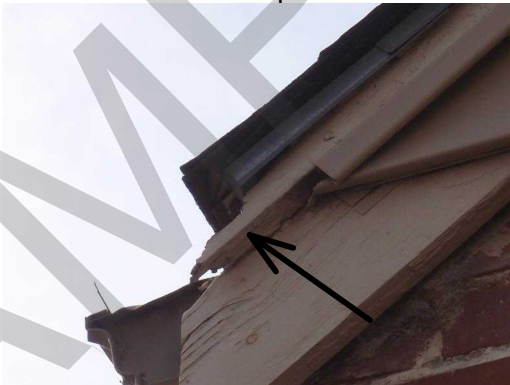
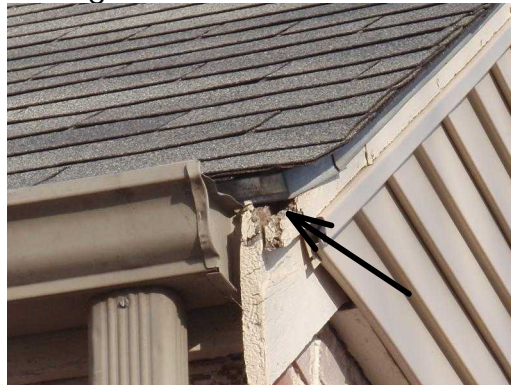
Fascia: Wood - Recommend repair to seal and paint open SE and SW fascia end corner boards, to prevent further damage,

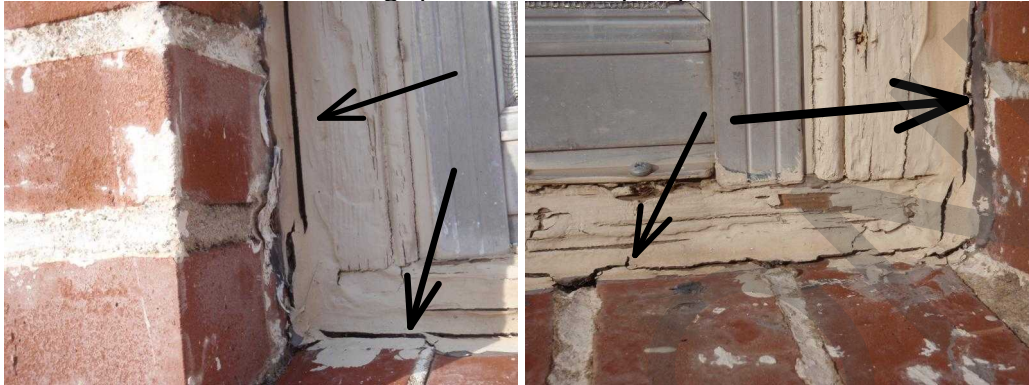
Flashing: Metal/ caulking. , recommend re caulking window frame wall joints that have cracked caulk with gaps, see example pictures,

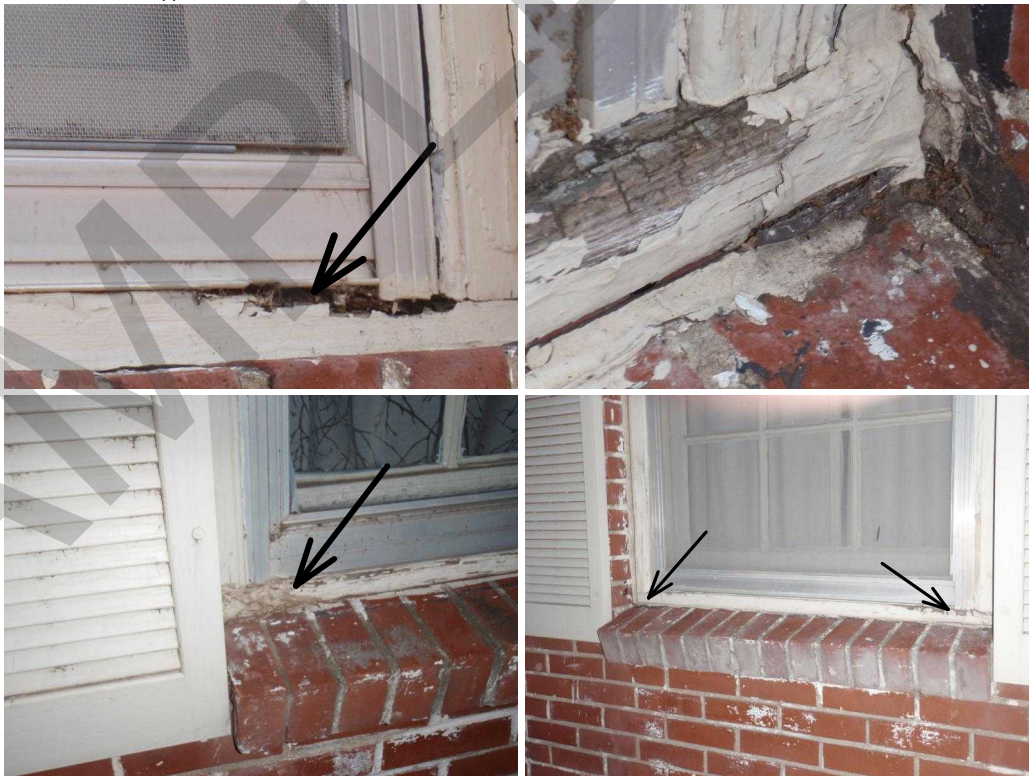
Windows: See flashing notes, - most windows due for paint and some glazing repairs, DEFECTIVE, Open dry rot on north wall and east wall window sills, recommend further evaluation and estimate to repair or replacement by window contractor,,

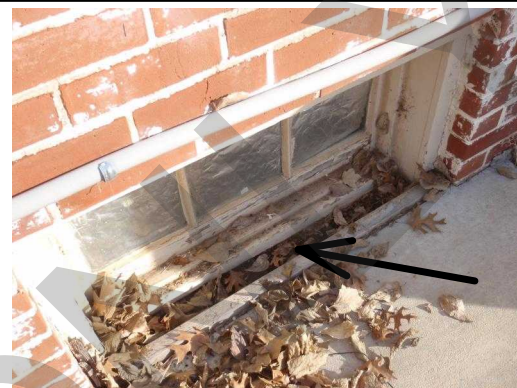
Basement Windows: west basement window at patio, - sill below grade, debris and water trap, recommend plastic cover over window to help divert debris and water away from sill,

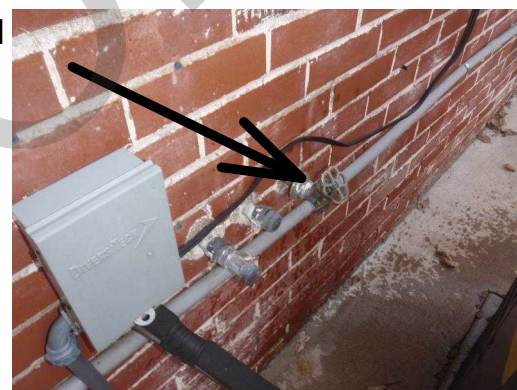
Hose Bibs: Gate - on west wall appears to be well feed, recommend upgrade to frost free bib or winterizing during winter months,

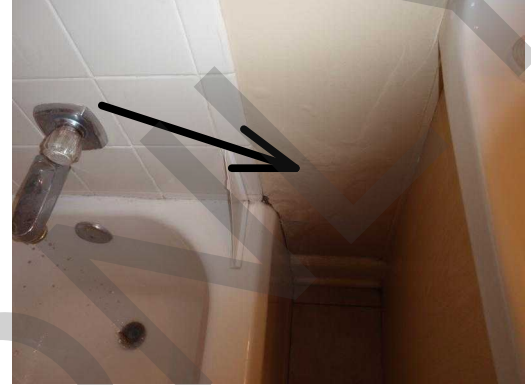
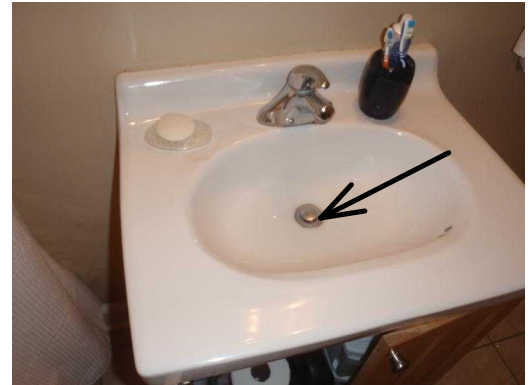
1. Defective Walls: crumbling water damaged area on west wall at tub, - recommend replacement to damaged area,
2. Acceptable Floor: Tile
3. Acceptable Electrical: 110 VAC GFCI
4. Acceptable Counter/Cabinet: Laminate and wood
5. Acceptable Sink/Basin: No defects found
6. Defective Faucets/Traps: No visible leaks, , slow drain on sink, suspect trap due for cleaning, Recommend repair as needed to drain.
7. Acceptable Tub/Surround: Porcelain tub and ceramic tile surround
8. Acceptable Toilets: No visible leaks or defects
9. Acceptable Ventilation: Electric ventilation fan

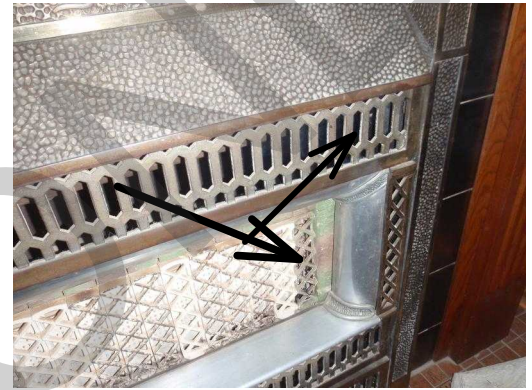
3. Defective Gas/Starter: Lit and tested for function, , smoking at damaged ceramic element on right side of unit, elevated C O at start up, recommend full clean and inspection and repair as needed with flue inspection before use, by qualified contractor.

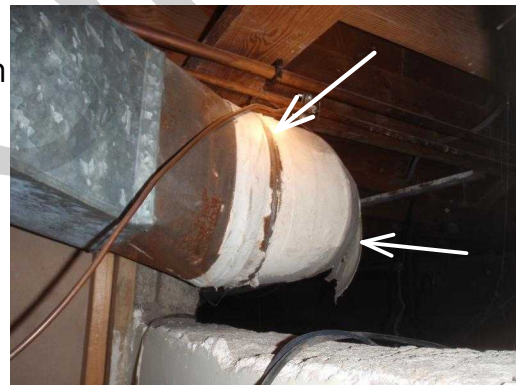
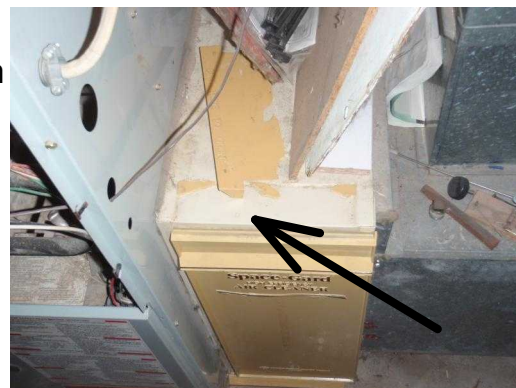
1. Acceptable Heating System Operation: Functional,
2. Type: Forced air Capacity: 88,000 BTUH
3. Area Served: Whole House Approximate Age: 8
4. Fuel Type: Natural gas
5. Not Inspected Heat Exchanger: Enclosed elements not visible.
6. Acceptable Thermostats: 1st floor wall
7. Marginal Exposed Ductwork: Metal - . loose friable asbestos wrap on duct in crawl, recommend encapsulation or removal by qualified contractor,

8. Marginal Blower Fan/Filter: Direct drive with reusable filter - Filter on slide tray at Furnace, recommend clean out at move in and every 2- 3 months. Filter cover broken, recommend new repair to secure cover,

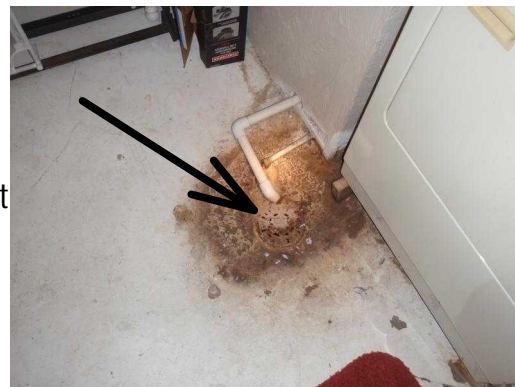
- 3. Acceptable Water Lines: Copper
- 4. Acceptable Drain Pipes: Cast iron - limited view from crawl hatch, See floor drain notes
- 5. Acceptable Washer hook up: Visible only line not filled
- 6. Marginal Floor drain: Surface Drain - , heavy build on floor at drain back up indicator, recommend asking seller if line cleaned since back up, recommend having underground lines scoped by plumbing contractor, due to past back up and slow drain at bath sink,

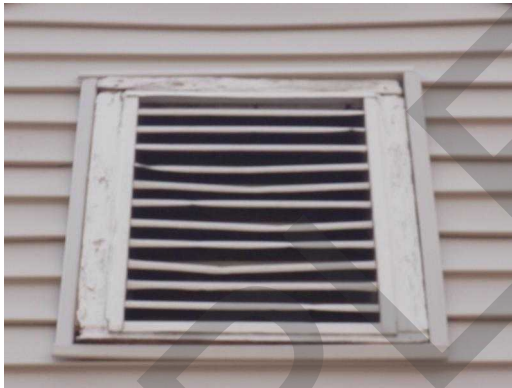
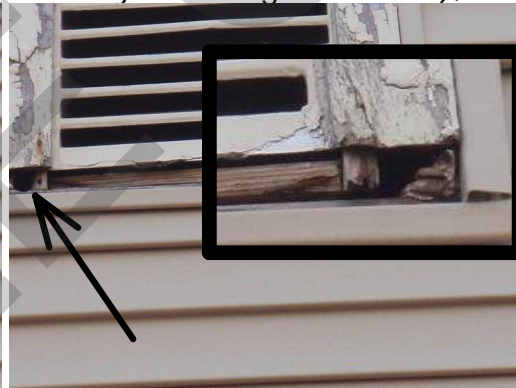
Ventilation: Gable Vents - , Wood vents due for paint and caulk, open damage on north wall gable vent, recommend repair or replacement, (FYI< recommend additional roof vents to vent attic to today's venting standards),

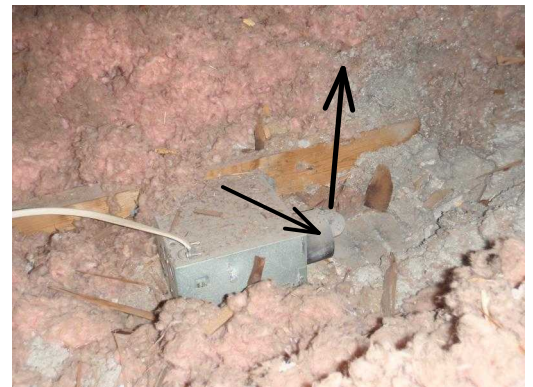
Bathroom Fan Venting: Recommend vent hose on bath fan to roof structure, to allow insulation cover on fan at ceiling,

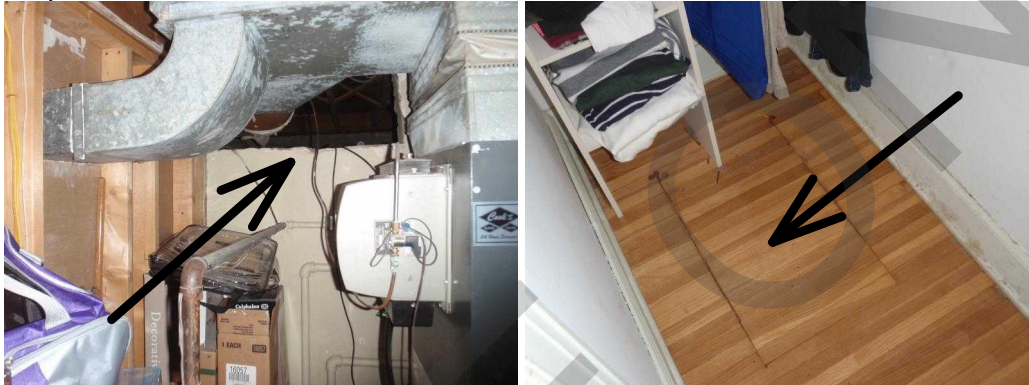
1. Method of Inspection: limited view from basement
2. Marginal Access: access from basement blocked by duct work and piping, p, - hatch in SW first floor bedroom closet floor in bind would not open, recommend repair to make inspection hatch in closet functional ,
